High Moisture Tar at Chicago Plant

High Moisture Tar at Chicago

D2-003-007

September, 1977

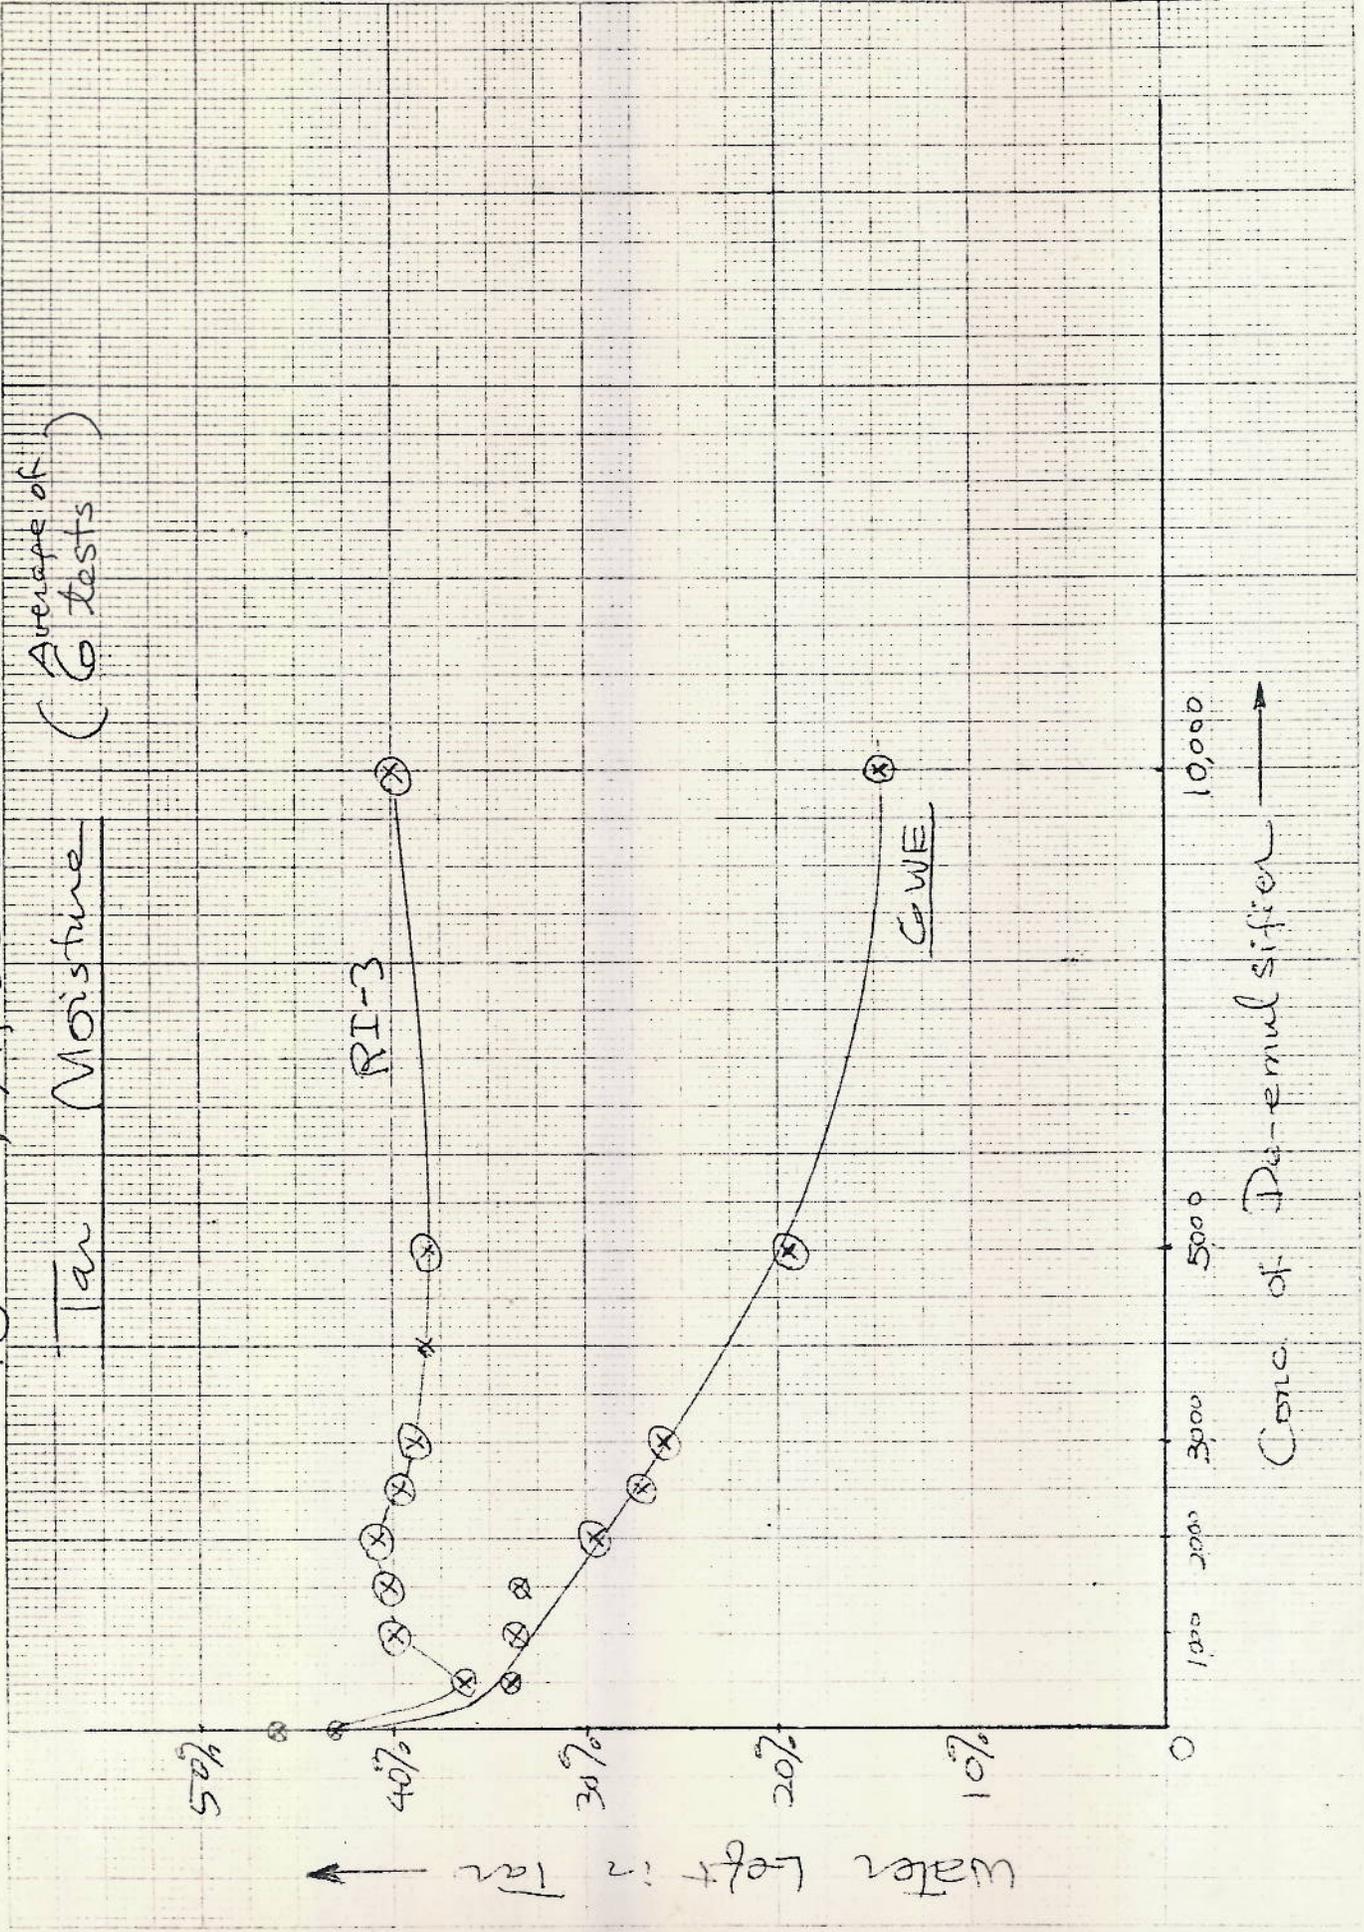
help us to keep tar moisture in line for almost ten years. Starting the summer of 1976, tar took a gradual increase in water content. At that time, after three month testing in site, it was found that heavier dosage of RI-3 was still able to remove tar moisture (Figure 3). Not every production tar sample could be de-watered under this kind of situation. However, by the time tar reached retention tank, they would be well-mixed. 90% trend would be a good approximation for the average tar. That means tar moisture could be maintain

low if 5000 p.p.m. RI-3 or more was used.

At that time, 2000 p.p.m. dosage was the normal dosage. Moreover, tar tested in Figure 3 was heated only 24 hours in water bath. In practice, tar averagely stays hot in decanters for 48 hours and again hot in retention tank for another 24 hours. Therefore, tar moisture would reduce further than what Figure 3 shown. No field test was performed at that time, because winter came and not enough heat could be maintained in decanters.
